INEEL/EXT-2000-00929

September 2000

OU 3-13 Tank Farm Interim Action Polyurea Demonstration Report

**Idaho National Engineering and Environmental Laboratory
Idaho Falls, Idaho 83415**

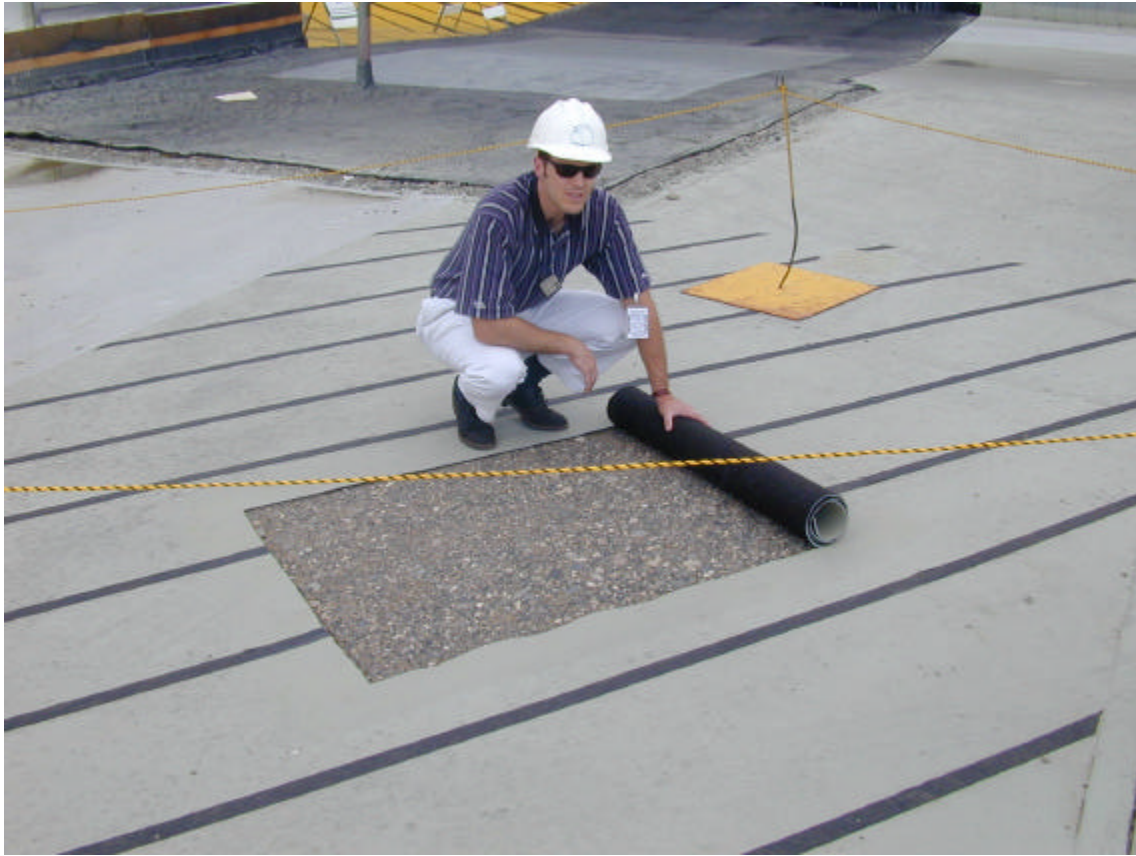
Area 2, cut and repair.

2.2.3.2.2 Liner Cut and Repair. On August 10, 2000, Stonhard performed a cut and repair demonstration on a 5 × 5 ft section of Area 2. The area to be cut was first cleaned with a solvent, and an irregular cut was made on three sides using an exacto knife. The cut section was then rolled back, as if work beneath was required. The section was then placed back to the original position and three 4-in. wide strips of geotextile (similar to the one used during the demonstration) were placed over the cut edges. A two-part slow-setting brush-grade polyurea was mixed by hand in a 1:1 ratio, and rolled over the geotextile. For test purposes, two coats of the polyurea were applied to the L shaped section of the patch closest to TB-6, and one coat was applied to the remaining side of the patch, closest to the existing gravel. Appendix F contains photographs of the patching process which was completed in approximately 1/2 hour.

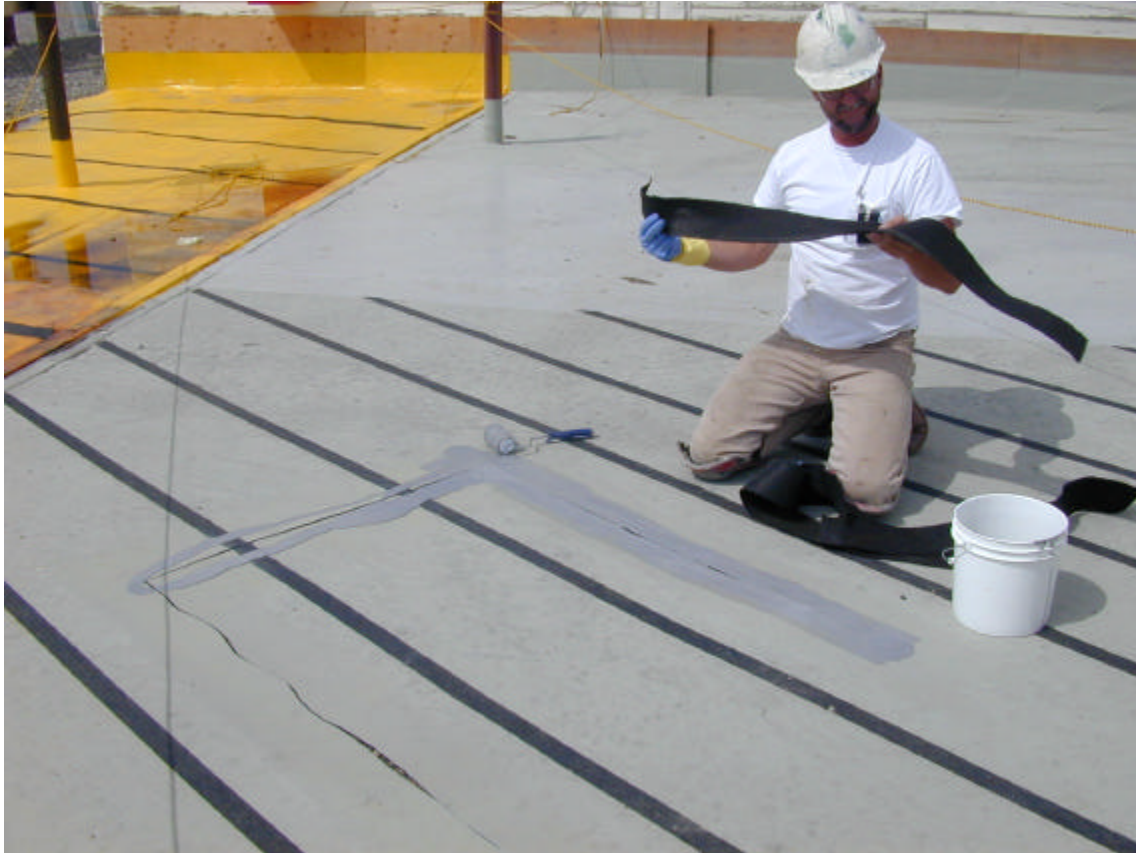
Area 2, application of patch.

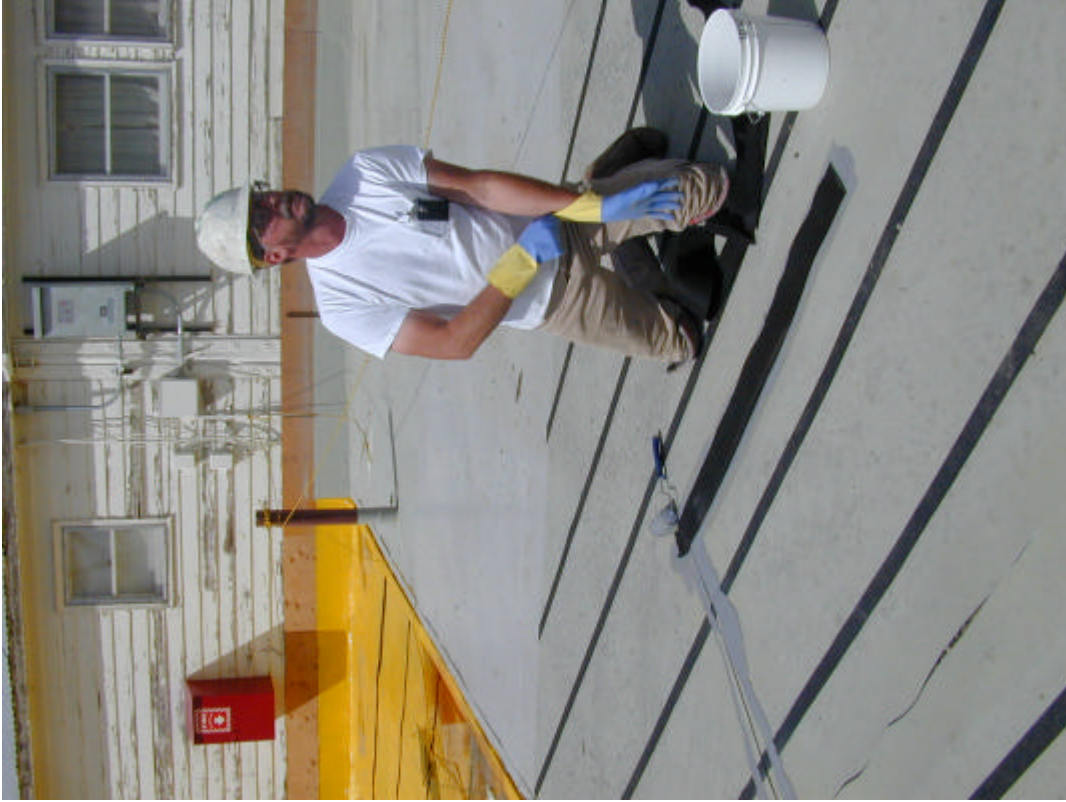
Area 2, application of patch.

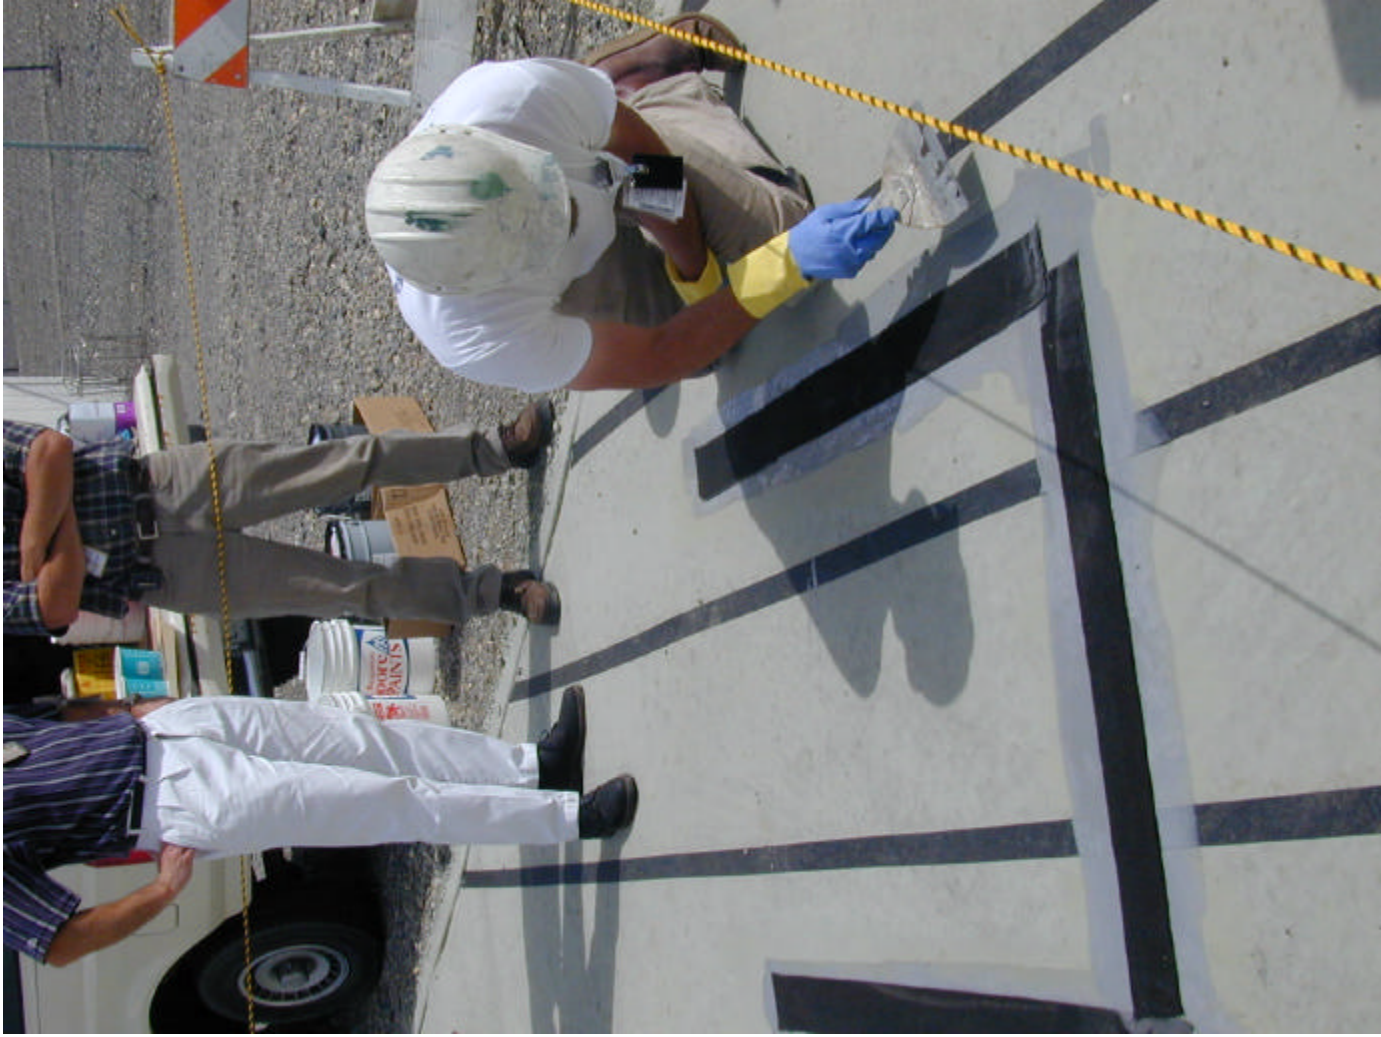
Area 2, application of patch.

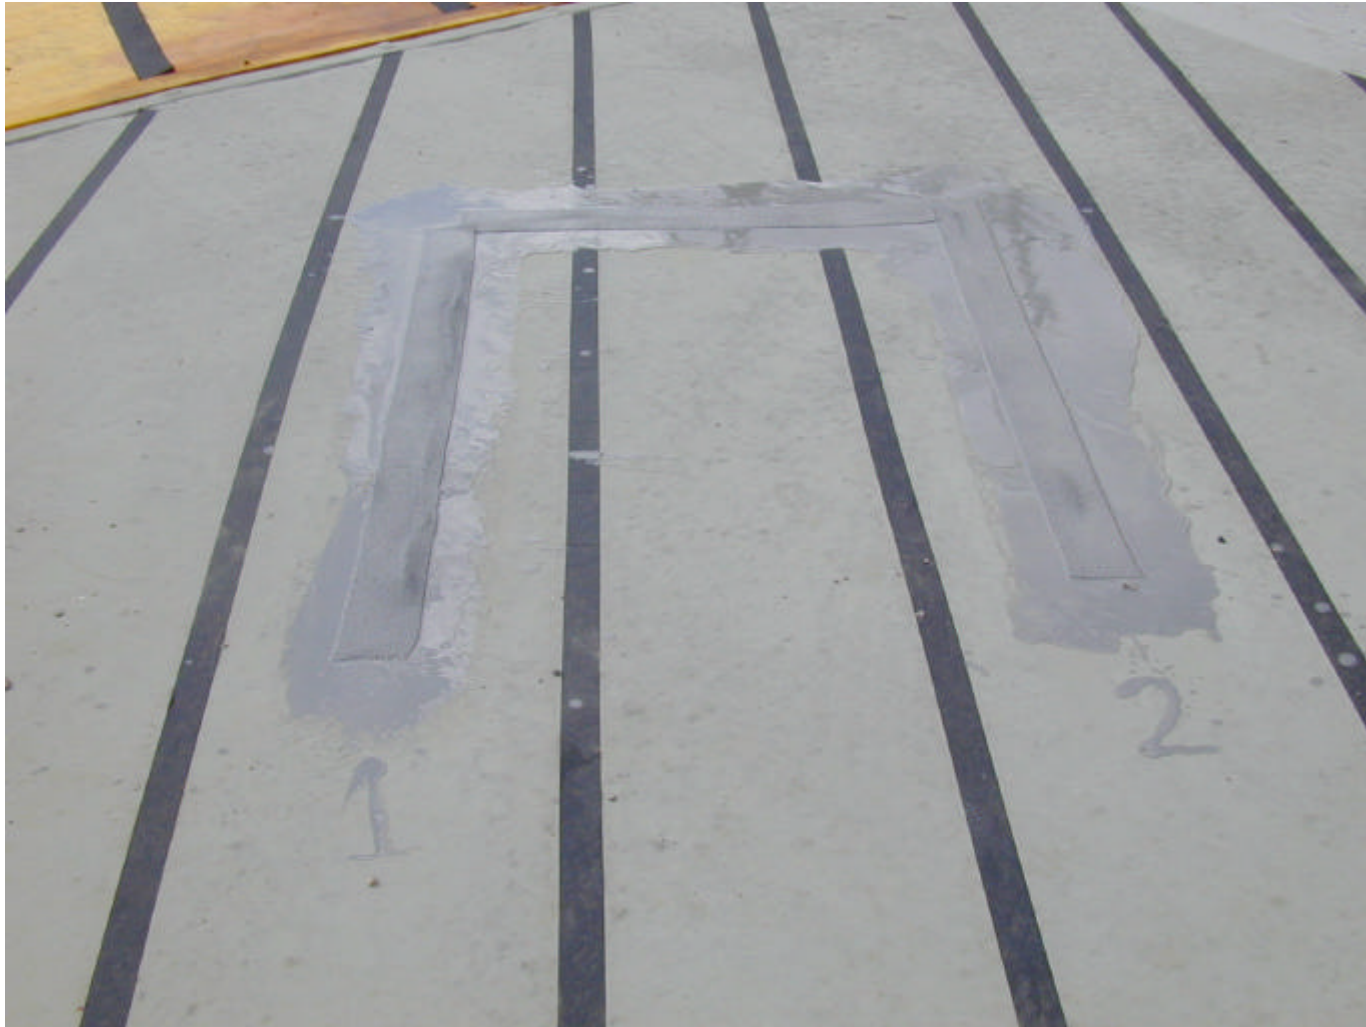
Area 2, patch complete.

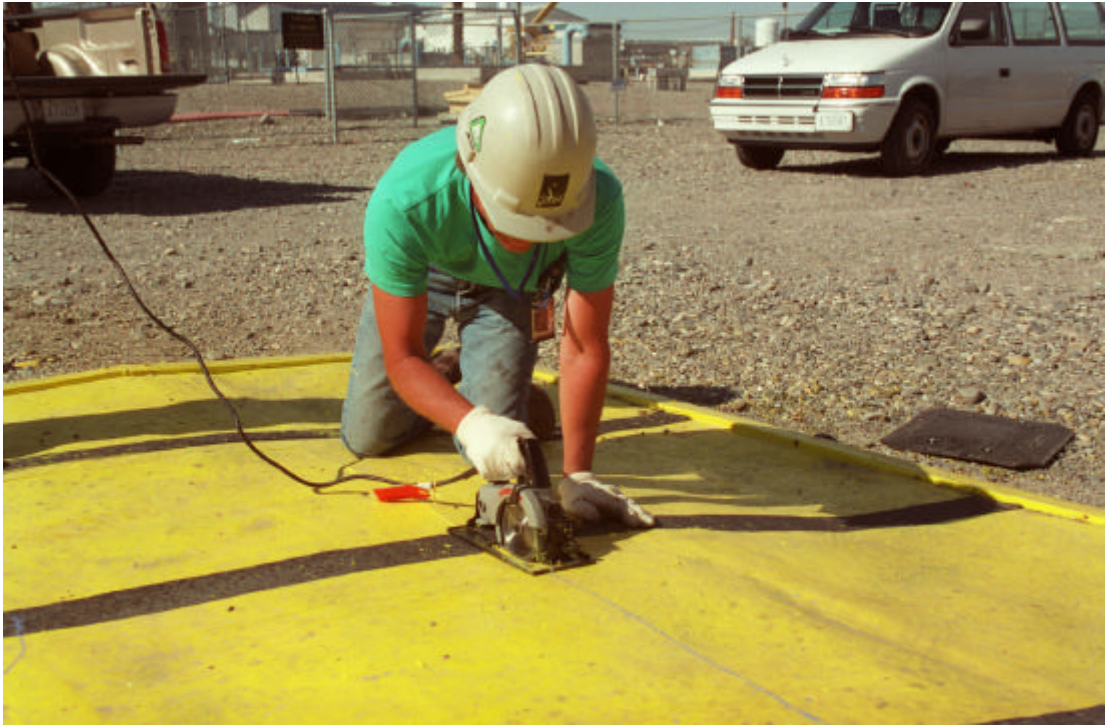
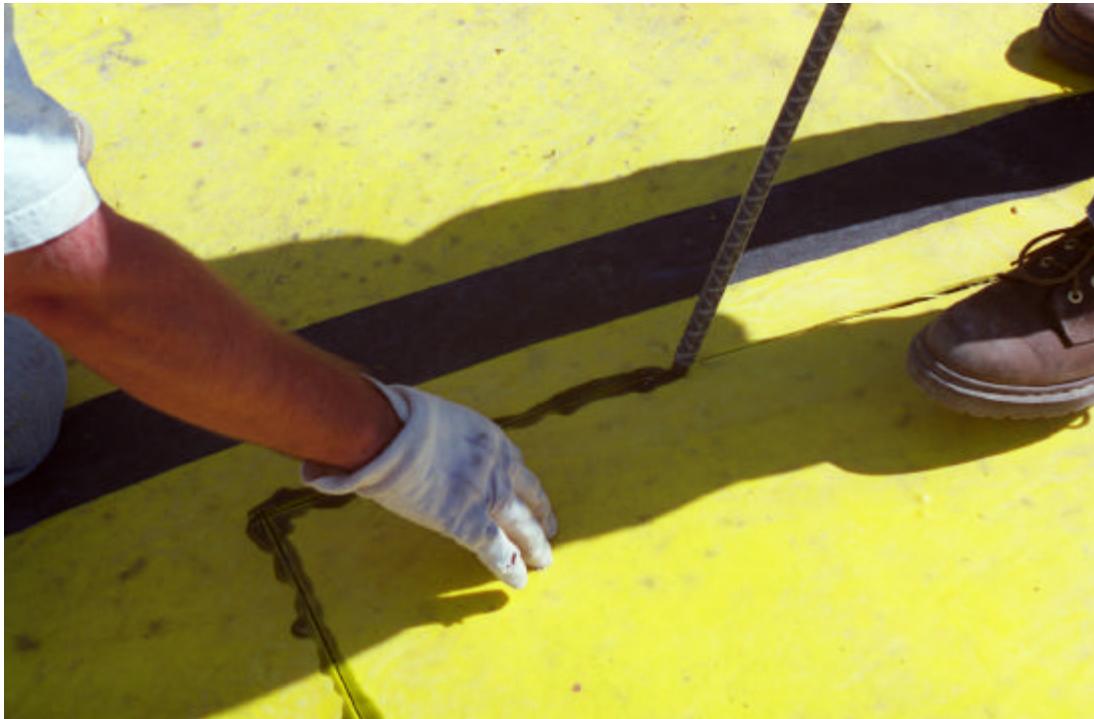
Area 1, cut and repair.

2.2.3.3.2 Liner Cut and Repair. On July 17, 2000, Sherwin Williams performed a cut and repair demonstration on a 5 × 5 ft section of Area 1. Three sides of this section were cut, and the cut section was rolled back, as if work beneath was required. The section was then placed back to the original position and the three edges were cleaned using a liquid product known as Lap Prep. A strip of filter fabric, which overlapped the damaged area, was laid down and a thick bead of Penatron 3003 was applied with a manual gun and smoothed into the fabric using a wide putty knife. A second coat of Penatron was applied to complete the patching process. The patching process was completed in approximately one hour. Appendix G contains photographs of the patching process.

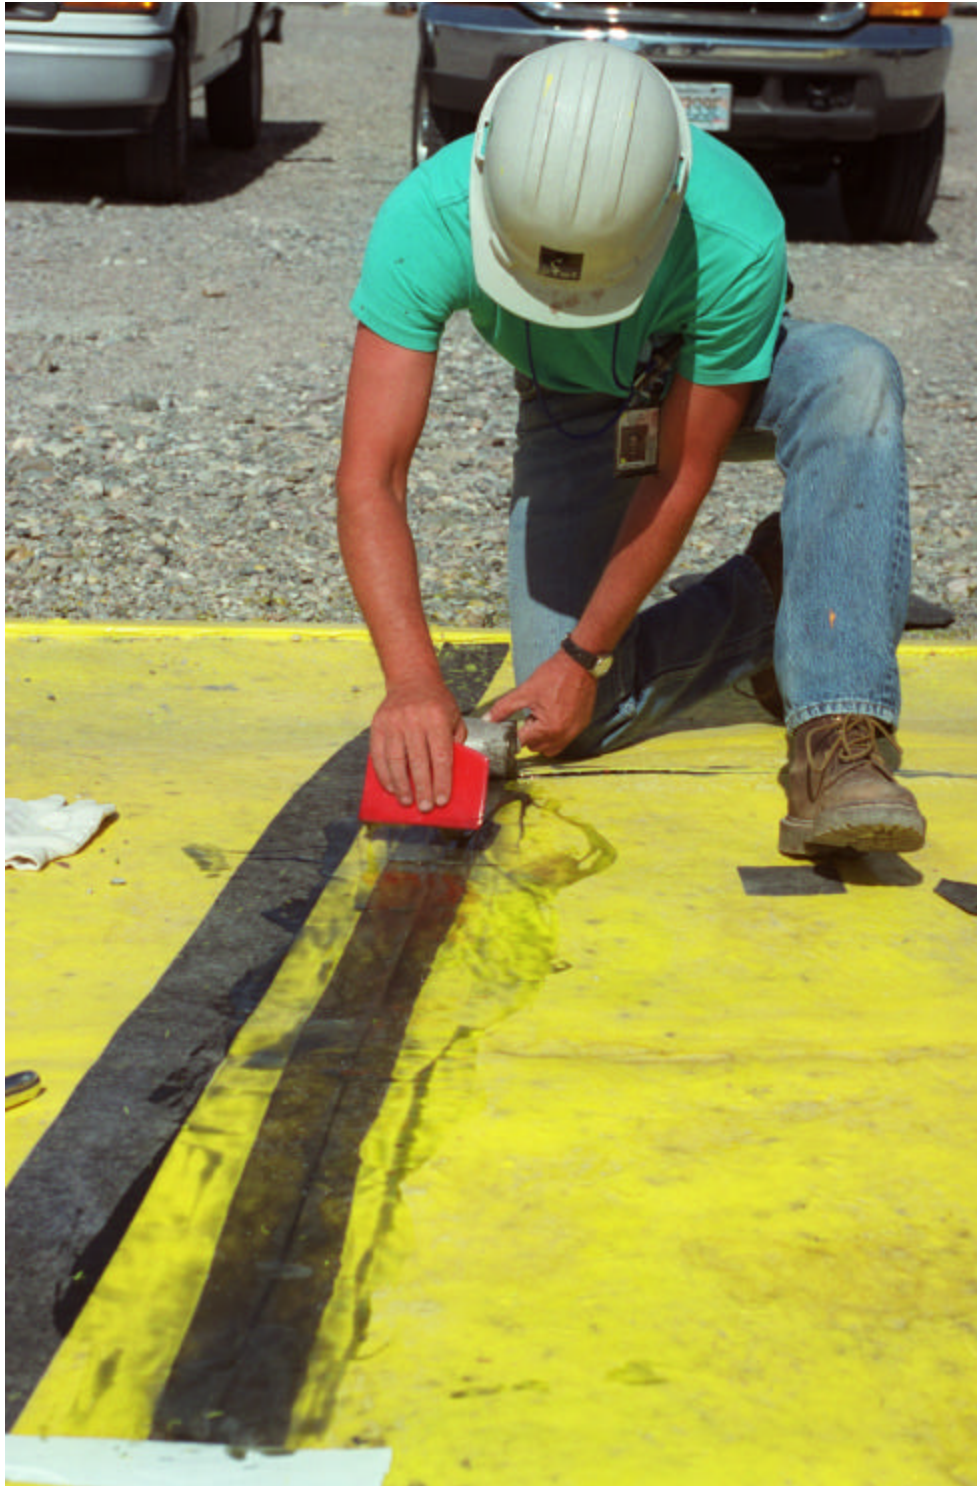
Area 1, application of patch.

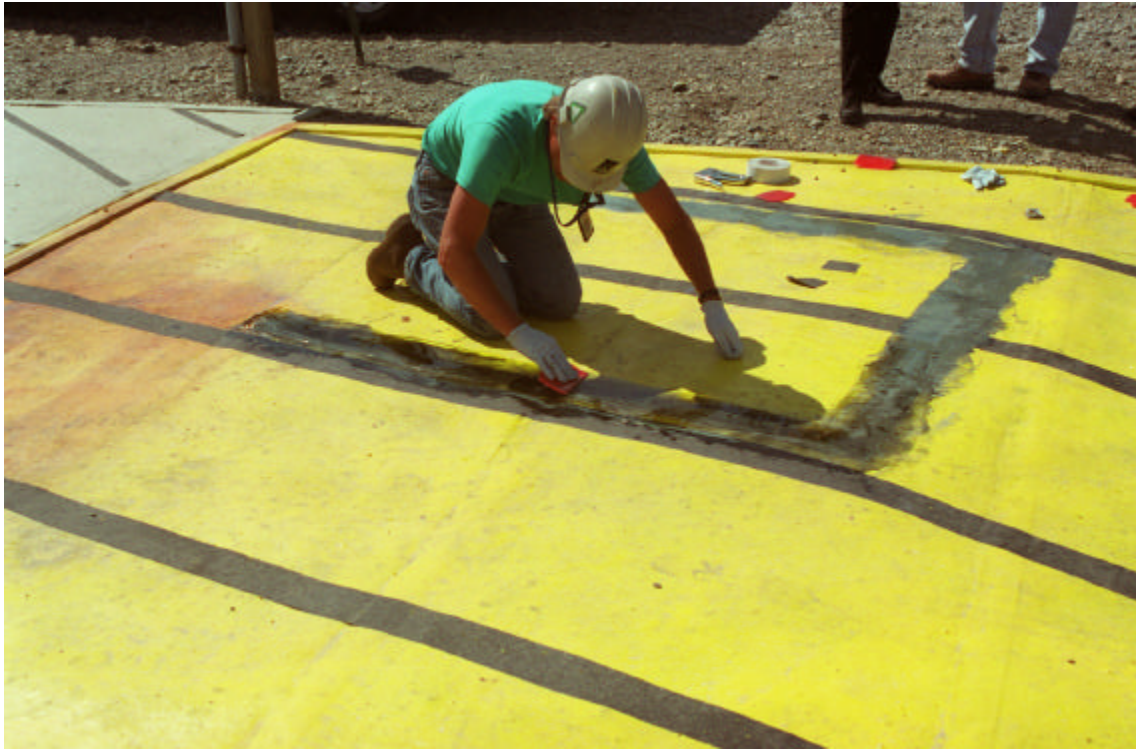
Area 1, application of patch.
